STAR ONLINE PUBLICATION

Case Number: S2123000009 Rev A

Symptom/Vehicle Issue: Water is leaking into cab through the third brake light CHMSL

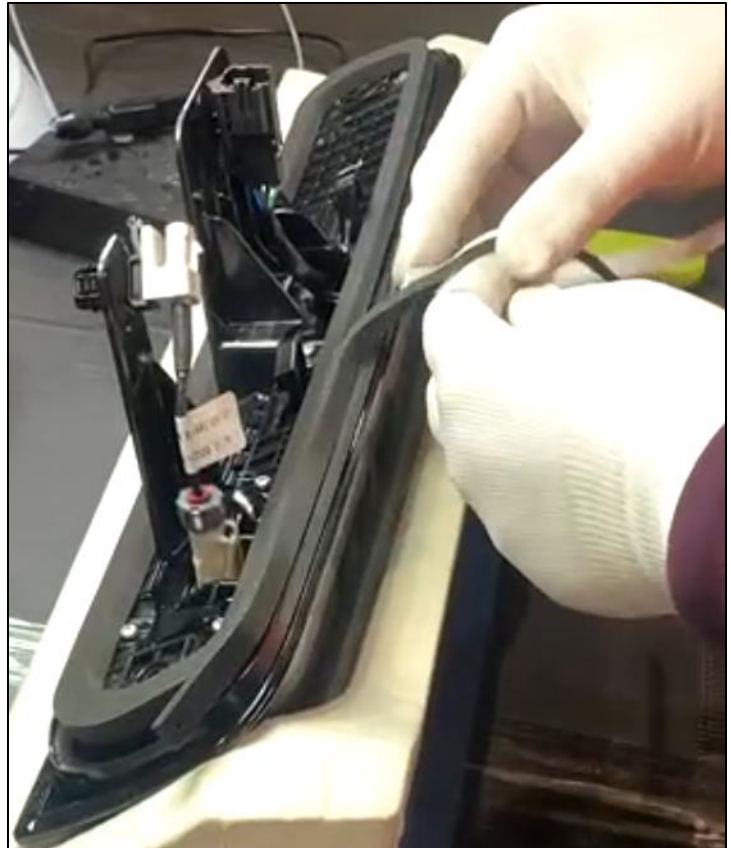
Customer Complaint/Technician Observation: Customer complains of water on the headliner / water at the back of the cab and technician observes a leak from the third brake light / CHMSL.

Order a replacement LED CHMSL (Part Number 68444540AB) and order a secondary gasket (Part Number 68545973AA).

Apply the secondary gasket directly onto the main gasket of the CHMSL. The secondary gasket should be at the top of the part when installed. Remove the adhesive backing from the secondary gasket as you go. You may want to use a ruler or credit card to lightly press the secondary gasket onto the main gasket.
